AN OVERVIEW OF URBAN SLUM GROWTH AND ENVIRONMENTAL DETERIORATION ON BULBULA AREA OF IBRAHIM KATSINA WARD, JOS, PLATEAU STATE

The Sustainable Development Goals adopted by the United Nation on the provision of clean water and sanitation (goal six) and sustainable cities and communities development (goal eleven) targeted for year 2030 and Nigeria's Vision 20:2020 Economic Transformation Blueprint cannot be overemphasized. The study is aimed at reviewing the growth of slums and environmental deterioration on Bulbula Area of Ibrahim Katsina Ward Jos, Plateau State. Its objectives are to identify the causes of slum growth and its negative effect on the landscape and find out strategies for solving the problem of environmental deterioration in slum communities. The methodology employed for this study is physical observation, oral interview and the review of related literature. Purposive random sampling technique was used to identify 40 houses under the study area. The study recommends that slum upgrading; planning and implementation should be inclusive of the input of urban designers working closely with slum dwellers, governments and other relevant stakeholders to ensure that prevalence

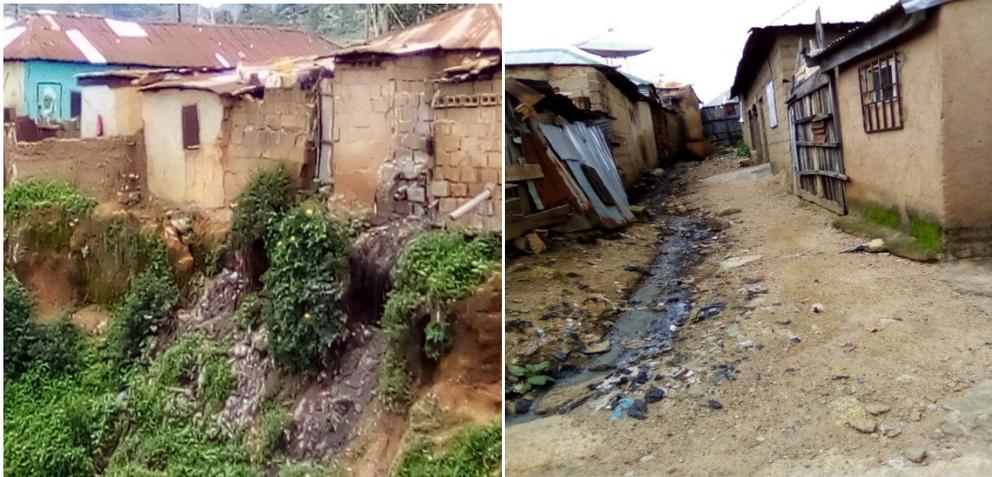
Physical observation reveals that the local building form is rectangular in shape .Most of the building materials used is very poor due to the low quality of materials used for their construction, inadequate technology and poor planning standards of the building components (Figure 2). This compares with the findings of (Morakinyo, et al., 2012; Ajayi, et al., 2014; and Bello, et al., 2018) of Nigeria where living conditions of the slum dwellers is very poor. Poor indoor air quality and contaminated construction materials are some of the health risks occupant are exposed to. According to Ajayi, et al., (2014) poor indoor air quality is associated with respiratory infection, chronic obstructive pulmonary disease, respiratory tract cancers, tuberculosis, cataracts, and asthma. The burning of solid fuels such as dung, wood, and coal, exposes people who use them to particulates, nitrogen and sulfur compounds, and benzene.

Figure 2: Unhealthy living condition in study area.
Source: Author's field photographs, 2020.

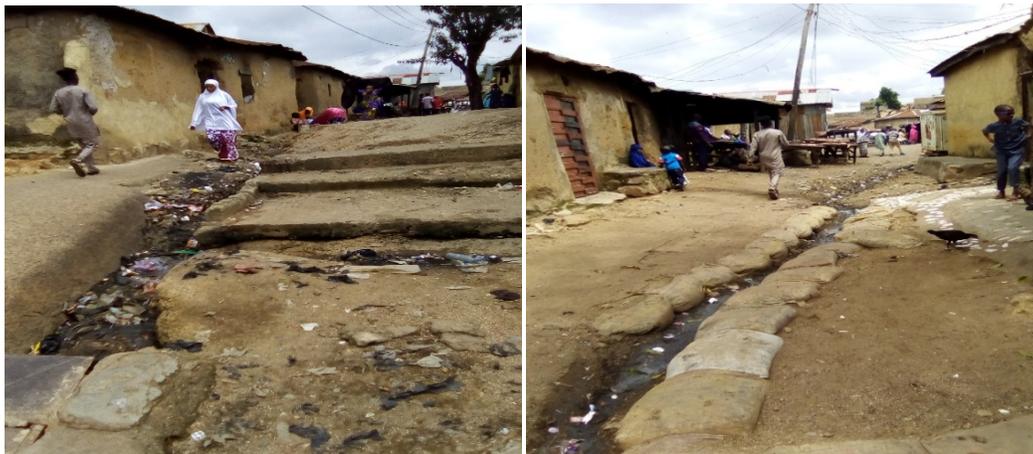
The slum can be accessed through the Nassarawa-Congo junction and through Zololo junction from Bauchi road. One would cross a popular bridge called (Gadan Sugai Bridge) to get to the community. Road widths are less than standard width, and rocky. Roads are seen to meander at

different points and corner due to the topography of the land which has lots of rock outcrops. Footpaths and walkways are seen not to be defined (Figure 3). The mode of accessibility in the present study compares with the findings of Morakinyo, et al., (2012) and Bello, et al., (2018) of Nigeria.

Figure 3: Accessibility to the slum community.
Source: Author's field photographs, 2020.

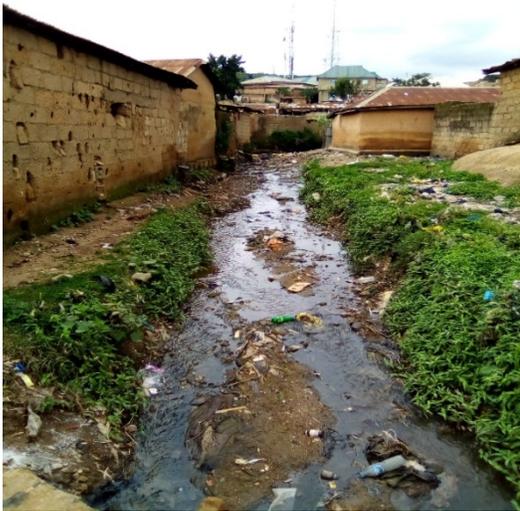
The findings from this section confirmed with the studies of (Morakinyo, et al., 2012; Pat-Mbano, et al., 2012; and Bello, et al., 2018) of Nigeria which reveals that the houses in the study area lack access to basic sanitation facility, very old in structure and condition. The sanitation services and waste

management is extremely poor and deplorable (Figure 4). Waste water flows directly in front of the houses and have become breeding grounds for vector agents i.e. mosquitoes. Drainage facilities are deplorable, non-functional or are operating below capacity (Figure 5). Other issues with the system include frequent blockage of sewer lines and leakage of untreated sewage into local streams and rivers.

Figure 4: Poor environmental sanitation services **Figure 5:** Deplorable drainage facilities.
Source: Author's field photographs, 2020.

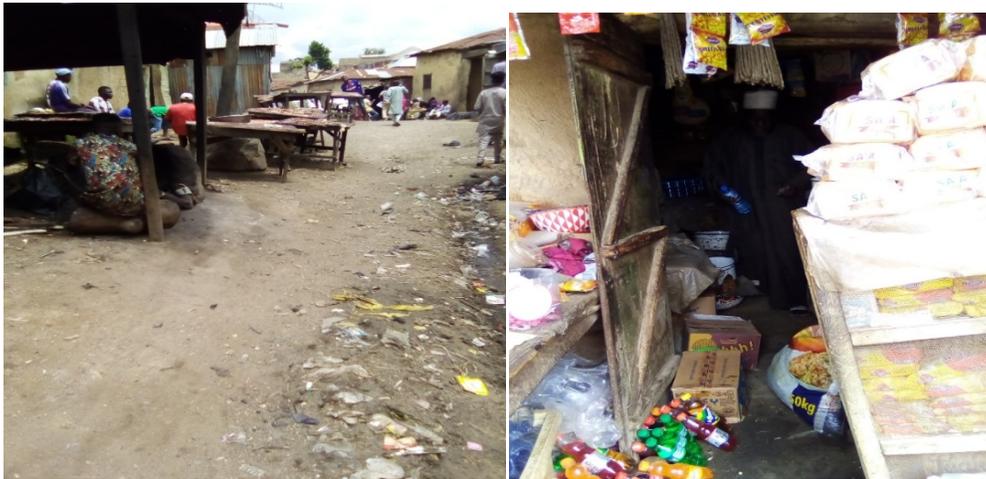
Trading activities such as sale of roasted meat, food items on trays and in buckets, fruits etc is done close to the deplorable drainage conditions on pedestrian lane, within the slum area thereby preventing

proper usage of pedestrian walkways (Figure 6). The findings from this study is very similar to that of Morakinyo, et al., (2012) who affirmed that slum dwellers perform business activities on the road, thereby preventing proper usage of the road.

Figure 6: Showing the slum dwellers performing business activities on pedestrian lane/road
Source: Author's field photographs, 2020.

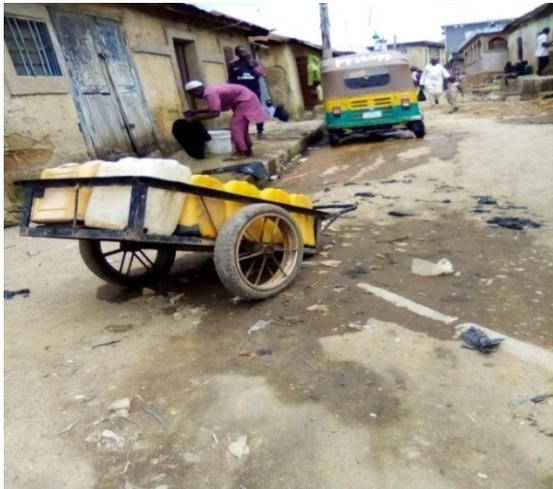
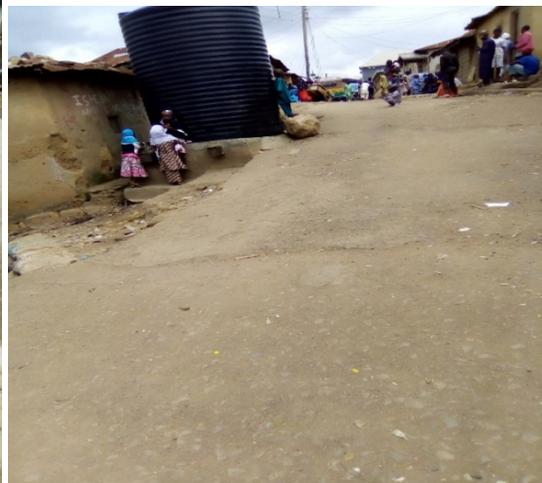
The findings from physical observation indicated the absence of pipe borne water supply leaving the inhabitants of the area with no option than to buy water for drinking and other domestic use from water vendors and from people who have sunk in boreholes for commercial purposes (Figure 7 and 8). Here 50 litres water-can (10 in number) sells for N250.00-N300.00. This compares with the findings of Daniel, et al.,

Figure 7: Water supply from a water vendor. **Figure 8:** Commercial water storage tank
Source: Author's field photographs, 2020.

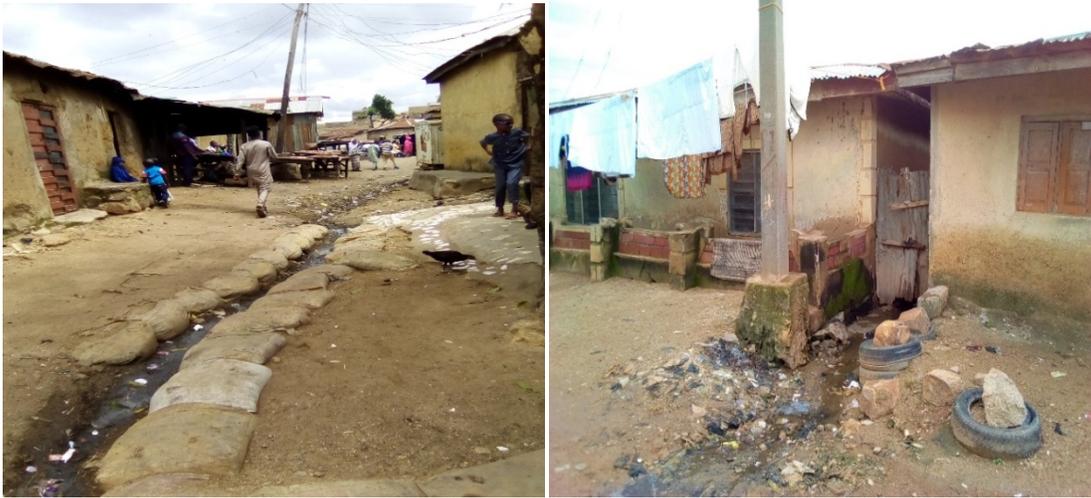
forest with its attendant consequences on global warming (Pat-Mbano, et al., 2012). Findings reveal location of high tension electric pole in front of the house can lead to electrocution of the inhabitants. No observed set-back to electric power line (Figure 9).

Figure 9: Location of high tension power line in front of dwelling units.
