# AN OVERVIEW OF URBAN SLUM GROWTH AND ENVIRONMENTAL DETERIORATION ON BULBULA AREA OF IBRAHIM KATSINA WARD, JOS, PLATEAU STATE

<sup>1</sup>EMMAMOGE OREWERE, <sup>2</sup>RUTH RAKIYA MARTINS AND <sup>3</sup>ATOMEN EDOM

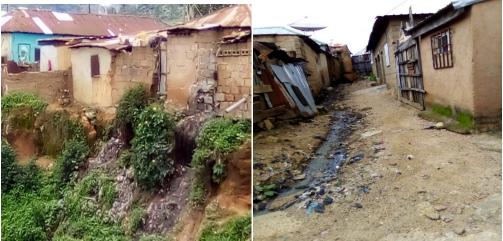
Physical observation reveals that the local building form is rectangular in shape .Most of the building materials used is very poor due to the low quality of materials used for their construction, inadequate technology and poor planning standards of the building components (Figure 2). This compares with the findings of (Morakinyo, et al., 2012; Ajayi, et al., 2014; and Bello, et al., 2018) of Nigeria where living conditions of the slum dwellers is very poor. Poor indoor air quality and contaminated construction materials are some of the health risks occupant are exposed to. According to Ajayi, et al., (2014) poor indoor air quality is associated with respiratory infection, chronic obstructive pulmonary disease, respiratory tract cancers, tuberculosis, cataracts, and asthma. The burning of solid fuels such as dung, wood, and coal, exposes people who use them to particulates, nitrogen and sulfur compounds, and benzene.

**Figure 2:** Unhealthy living condition in study area. Source: Author's field photographs, 2020.

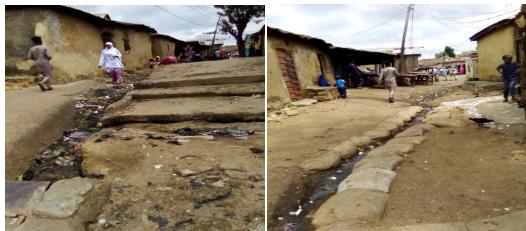
The slum can be accessed through the Nassarawa-Congo junction and through Zololo junction from Bauchi road. One would cross a popular bridge called (Gadan Sugai Bridge) to get to the community. Road widths are less than standard width, and rocky. Roads are seen to meander at

different points and corner due to the topography of the land which has lots of rock outcrops. Footpaths and walkways are seen not to be defined (Figure 3). The mode of accessibility in the present study compares with the findings of Morakinyo, et al., (2012) and Bello, et al., (2018) of Nigeria.

**Figure 3:** Accessibility to the slum community. Source: Author's field photographs, 2020.

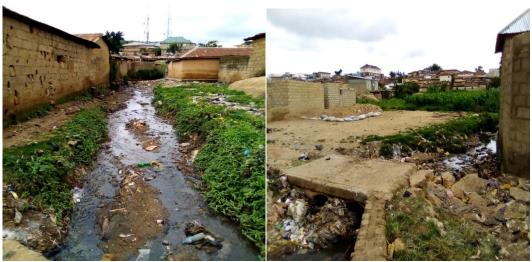
management is extremely poor and deplorable (Figure 4). Waste water flows directly in front of the houses and have become breeding grounds for vector agents i.e. mosquitoes. Drainage facilities are deplorable, non-functional or are operating below capacity (Figure 5). Other issues with the system include frequent blockage of sewer lines and leakage of untreated sewage into local streams and rivers.

**Figure 4:** Poor environmental sanitation services **Figure 5:** Deplorable drainage facilities. Source: Author's field photographs, 2020.

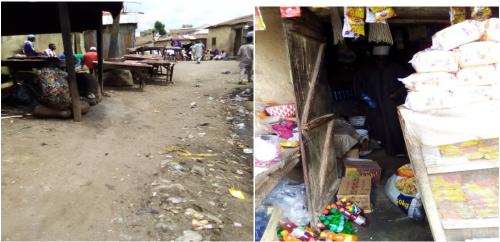
Trading activities such as sale of roasted meat, food items on trays and in buckets, fruits etc is done close to the deplorable drainage conditions on pedestrian lane, within the slum area thereby preventing proper usage of pedestrian walkways (Figure 6). The findings from this study is very similar to that of Morakinyo, et al., (2012) who affirmed that slum dwellers perform business activities on the road, thereby preventing proper usage of the road.

**Figure 6:** Showing the slum dwellers performing business activities on pedestrian lane/road Source: Author's field photographs, 2020.
